WALL ARMOR PULLOUT TESTING

Structural Laboratory

DEPARTMENT OF THE ARMY
CONSTRUCTION ENGINEERING CENTER
FORT BELVOIR, VIRGINIA

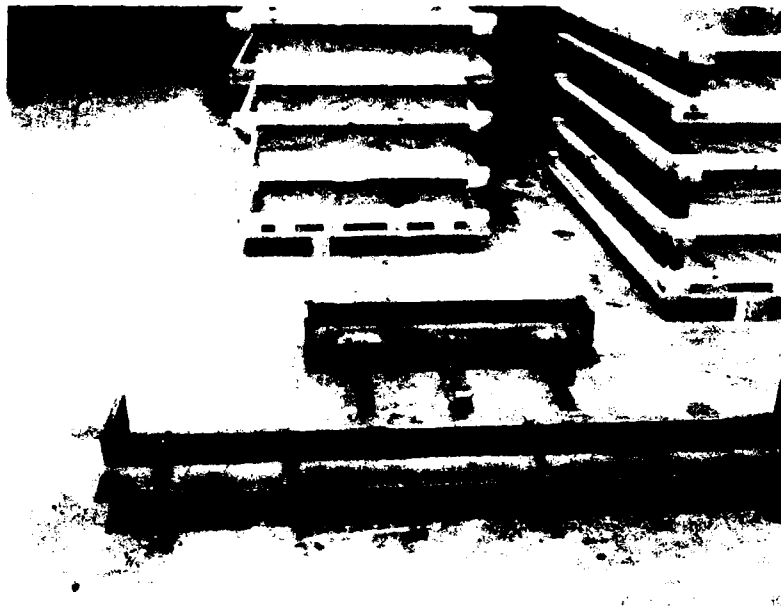
Figure 1. Typical anchor strap and headed stud wall armor assemblies

5. A total of eight wall armor assemblies were fabricated and embedded in concrete specimens during the test program. Typical assemblies can be seen in Figure 1, and shop drawings detailing dimensions are given in Plates 1 and 2. A summary of the fabricated assemblies is given in Table 1.

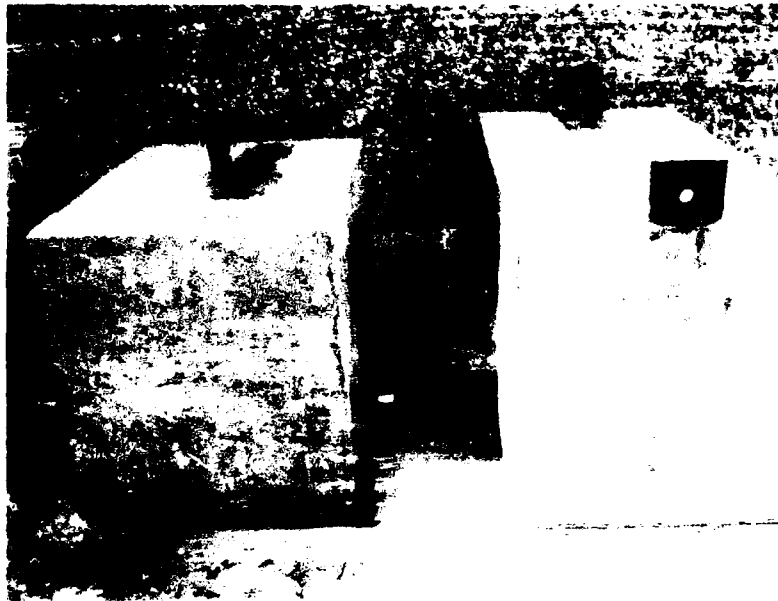
Figure 3. Wall armor assemblies embedded in concrete specimens

9. Eight concrete specimens were cast during the test program. Four of these specimens measured 2 ft 9-1/2 in. in width, 6 ft in length, and 3 ft in height. The remaining four specimens were similarly dimensioned with the exception of being 4 ft in length. In each specimen wall armor assemblies were embedded such that only the flanges of the wall armor remained exposed as shown in Figure 3. For specimen anchorage to the test floor, four 2-in.-diam steel bars, 12-3/4 in. long, were embedded to a depth of 12 in. in each of the 4-ft-long concrete specimens, 10 in. in height from the bottom of the test blocks. In the 6-ft-long concrete specimens, two 2-in.-diam bars were embedded throughout the width of the test blocks with an overhang of 5-3/4 in. on either side of the test blocks. These were also positioned 10 in. in height from the bottom of the test blocks. These bars are visible in Figure 3. Also, in each 6-ft-long concrete specimen, six No. 8 reinforcement bars were

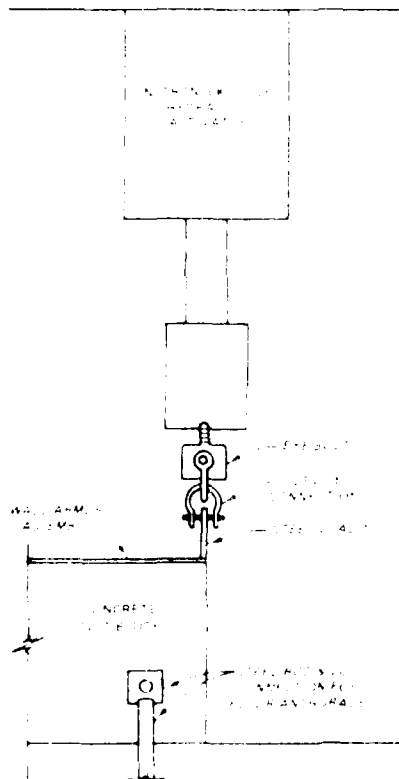
Figure 4. Typical setup for testing of wall armor assemblies

10. The four 6-ft assemblies were designed such that they could be tested on each end. After one end was tested, the block was rotated and tested on the opposite end. The test program was designed to perform a total of eight pullout tests on the 6-ft assemblies. Steel plate loading lugs, 7-3/4 by 7-3/4 by 3/4 in., with a 1-1/2-in.-diam hold were welded to the top of the flanges at each end to provide for loading attachments. Pullout loading of the wall armor was provided by an Instron 300,000-lb closed-loop hydraulic testing system that was attached to the foot of the actuator and the loading lugs by eyebolt and clevises (Figure 4).

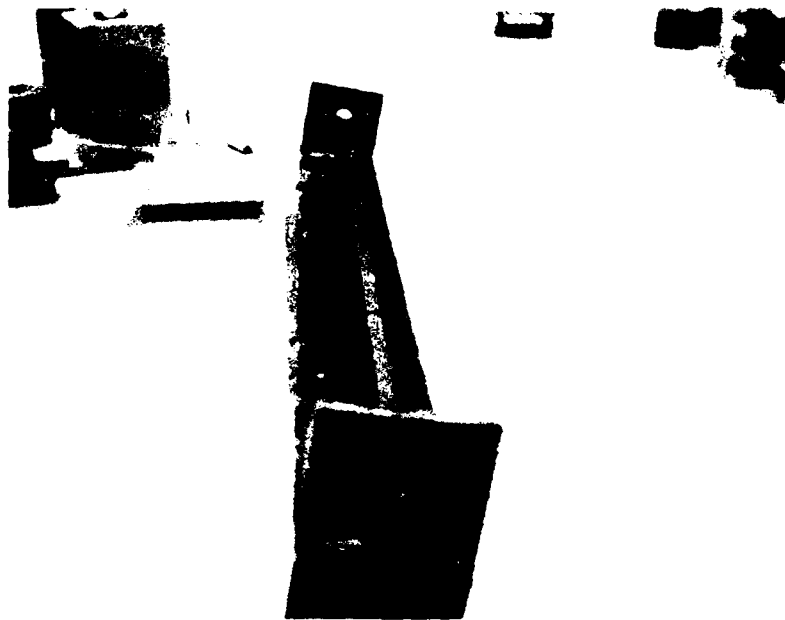
Figure 5. Wall armor assembly with addition of stiffening member

14. Throughout the test program, 13 pullout tests were performed. Of these, nine were successful by definition of failure set forth in paragraph 13. The results of these pullout tests can be seen in Table 2. Two of the three unsuccessful tests were the direct result of failure of weld joints at loadings well below what was expected. After two consecutive pullout tests resulted in weld joint failures, it was decided that 3/4-in.-thick by 4-in.-high steel stiffening members be welded along the top center of the flanges of the remaining 6-ft assemblies to distribute bending stresses over the flanges and thereby reduce the stresses on the weld joints beneath the flange (Figure 5). On the 3-ft assemblies, two stiffeners were welded across the width of the flanges in the center of the wall armor on the remaining assemblies to accomplish the same stress distribution.

the first two tests on the 6-ft headed stud assemblies and the first test on the 3-ft headed stud assembly were conducted without the stiffening members which were later added. However, the subsequent tests on the 6-ft headed stud assemblies with stiffeners yielded loading values in the same range as without the stiffening members. Therefore, it is believed that the addition of the stiffening members did not significantly affect the test results.

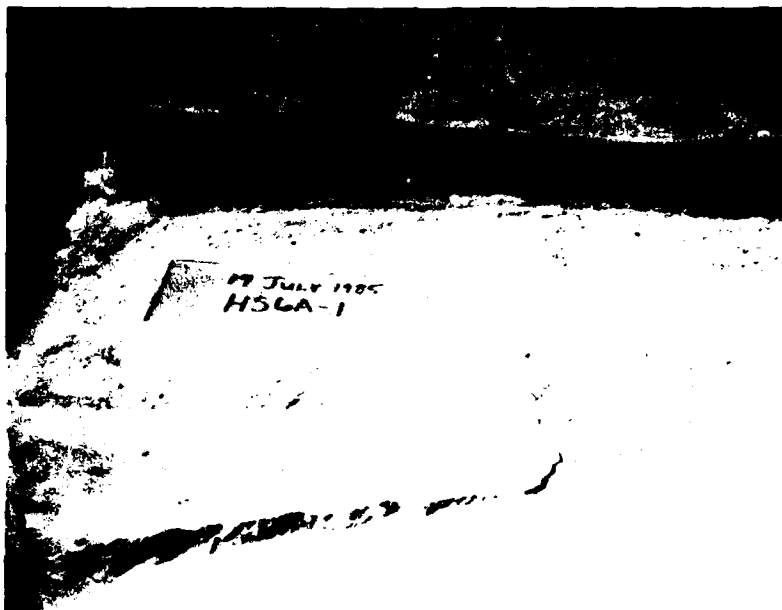
Photo 1. Wall armor test failure, assembly HS6A-1

15. All of the successful tests conducted on the 6-ft assemblies failed first by producing failure cones in the concrete. Photos 1-8 show these failures. Plates 3-10 contain the raw data from the load versus deflection test plots. In the failure of the 6-ft assemblies, concrete rupture was followed by pullout of the wall armor with the exception of assembly AS6B-2. In this assembly, failure near the top surface of the concrete test block was impending (as evident by the presence of failure cracks) when rupture of the concrete occurred at the level of the anchor bar inclusion mentioned in paragraph 9. The loading range and the pattern of the failure cracks were the same as with the other 6-ft anchor strap tests at failure. Therefore, this was also considered a good test. The boundaries of the failure cones for the headed stud assemblies were at a depth close to the depth of the headed studs. For the anchor strap assemblies, the failure plane was very near the top surface of the concrete test blocks. The anchor strap wall armor tests realized the higher pullout resistance with a loading range from 64,000 to 82,000 lbf for an average of 72,000 lbf. The headed stud assemblies provided

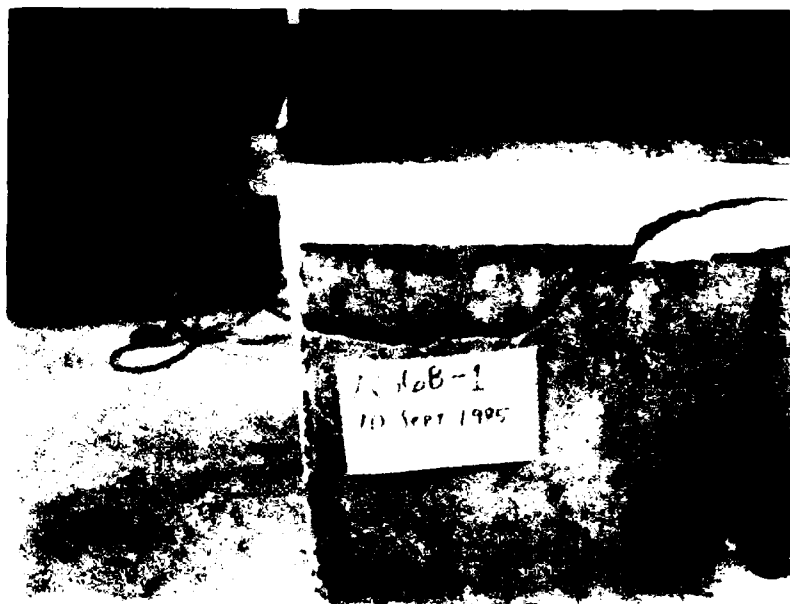
Photo 7. Wall armor test failure, assembly AS6B-1
